Area in Need of Redevelopment Investigation

***BLOCK 815, LOTS 1.01, 6 AND 7 (Town Hall Complex)
TOWNSHIP OF MIDDLETOWN, MONMOUTH COUNTY,
NJ***

JUNE 2017

Sanyogita S. Chavan, P.P., A.I.C.P.

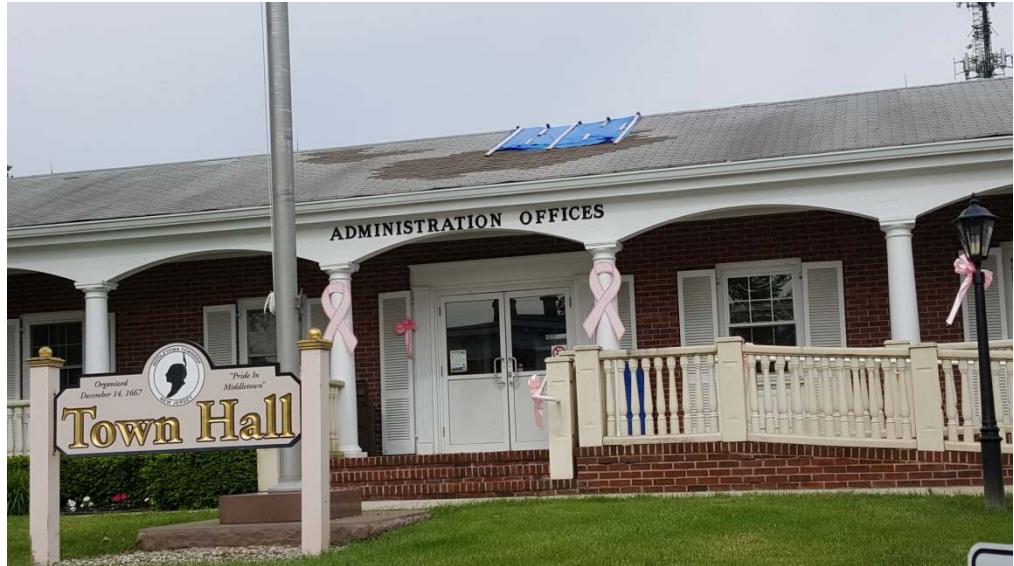
Administration Building

View of the eastern façade of the main administration building depicting the visible roof leakage and the temporary measures adopted to address this.

A photograph showing a blue portable pump on a concrete surface next to a red brick wall. A green garden hose is connected to the pump. In the background, there is a metal railing and a paved area with a few parked cars.	A photograph of a room that has been flooded. The floor is covered in water and debris, including a white bucket and some green items. The room has brick walls and a window.	Flooding along the northern façade of the building. This is an ongoing issue, which gets exacerbated during a storm event.
--	---	--

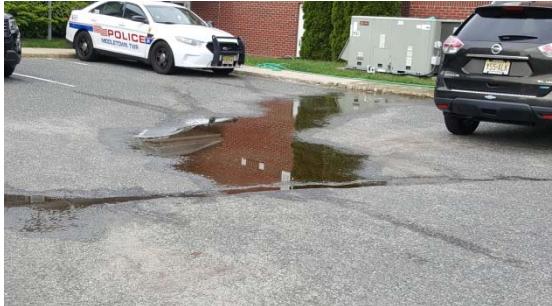
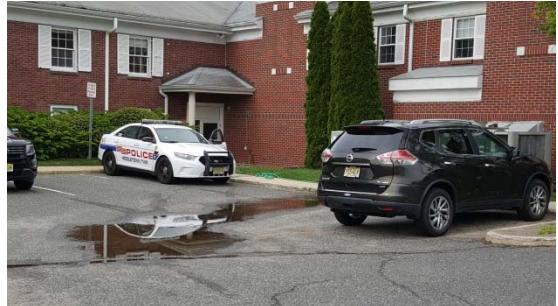
View looking towards the northern façade from the parking lot, and depicting the direction of flow of the rainwater towards the northern portion of the building.

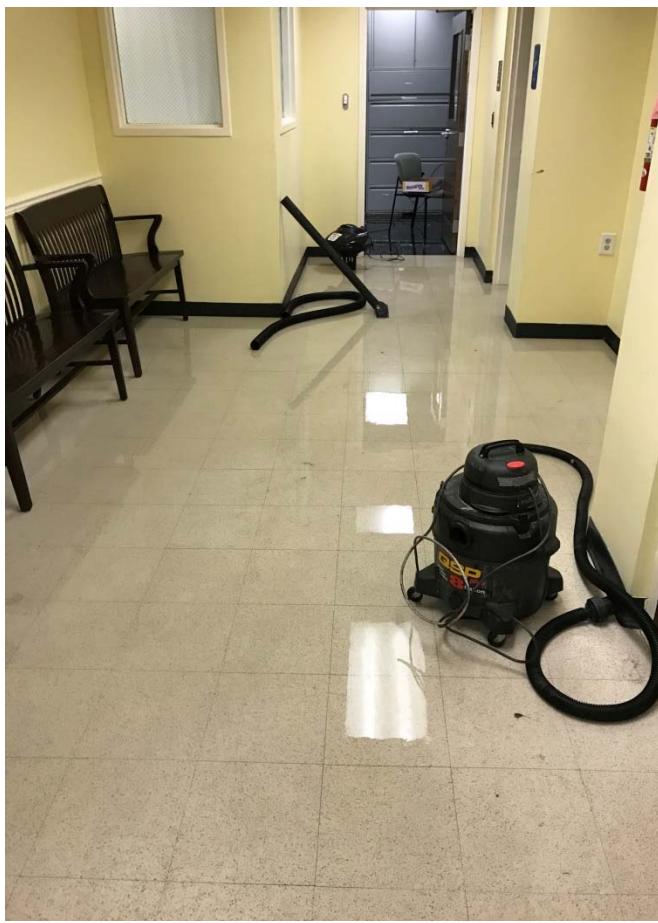
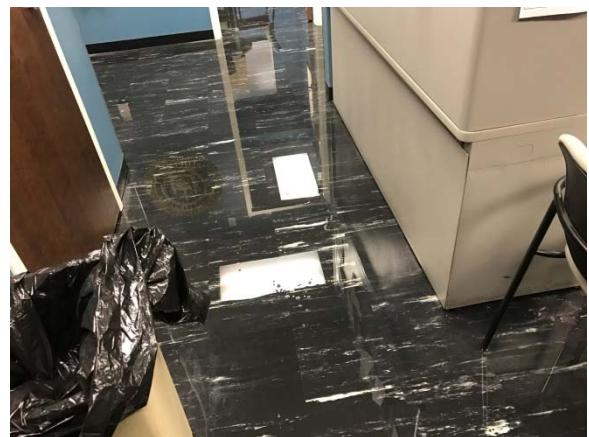
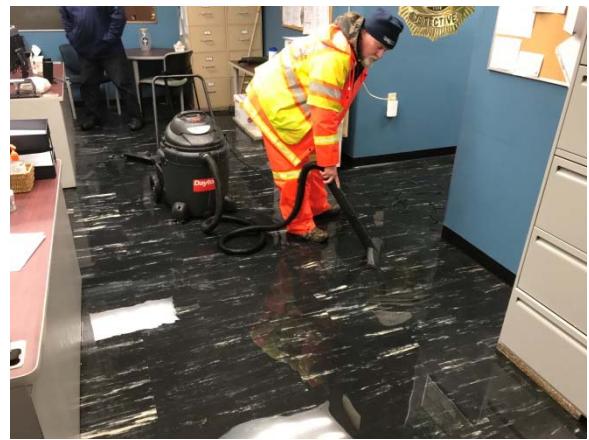
The above photos illustrate flooding in the basement of the building that houses the various functions of Middletown Township's Police Department. Flooding is an ongoing issue during storm events in the Township.

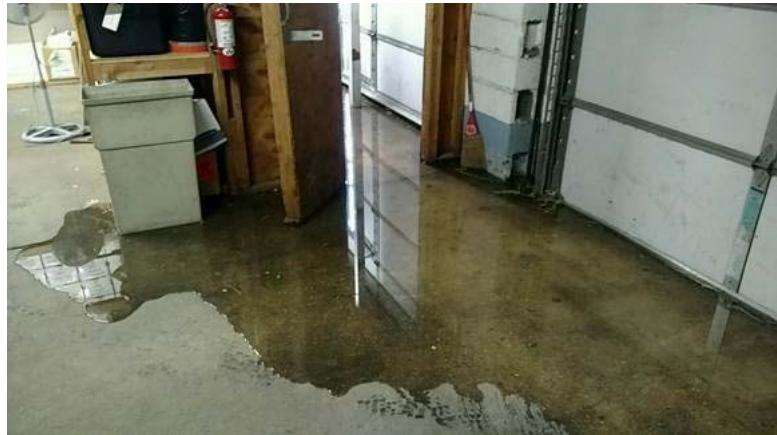
View of the flooding in the basement of the Town Hall building.

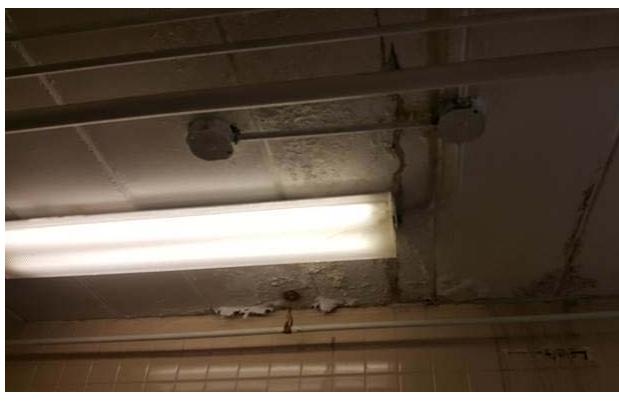
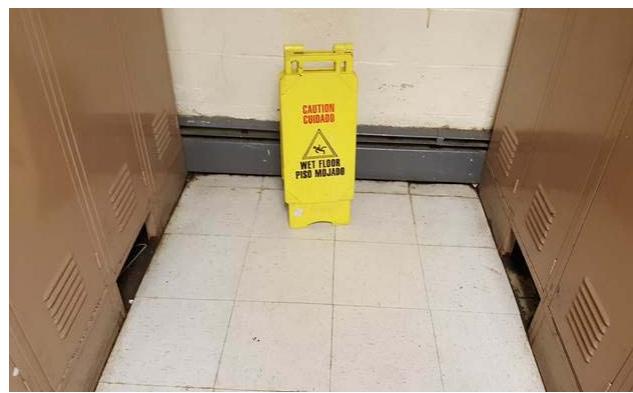
The image to the left is of the water damaged ceiling in the men's bathroom. And the image to the right shows flooding in the locker room during a storm event.

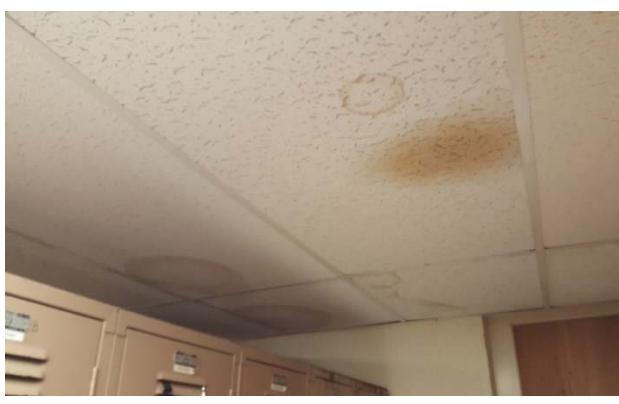
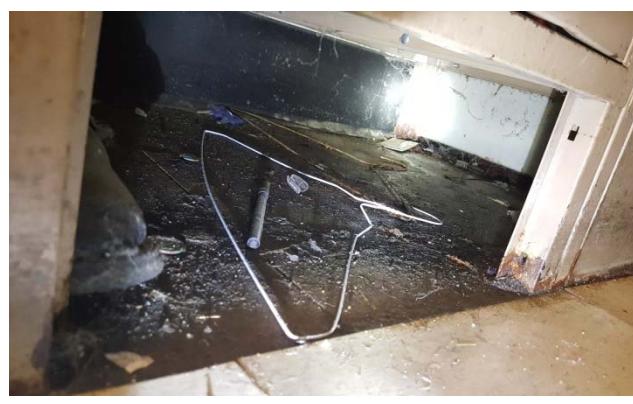
Left: View of the locker room ceiling showing water seepage. The ceiling tiles were replaced recently but the ongoing issue with water seepage and the resulting damage is evident. The image to the right illustrates the water damage under the lockers.

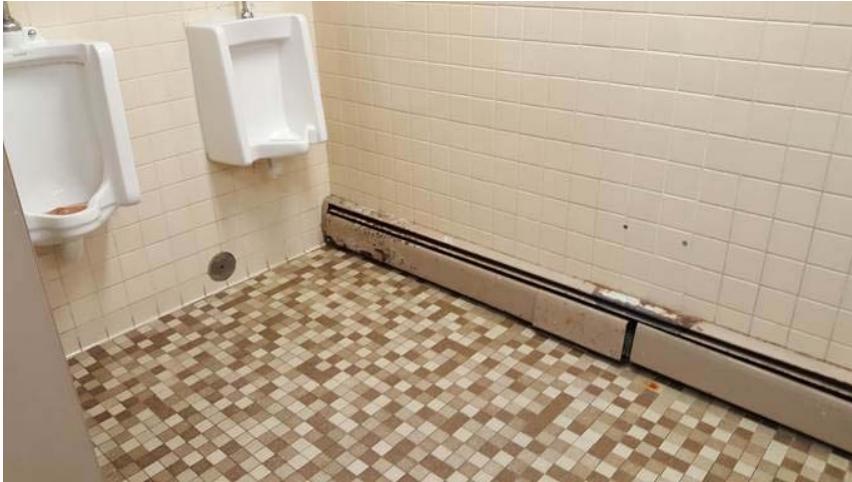
The above photo illustrates the toilet overflow caused due to sewer pump failure.

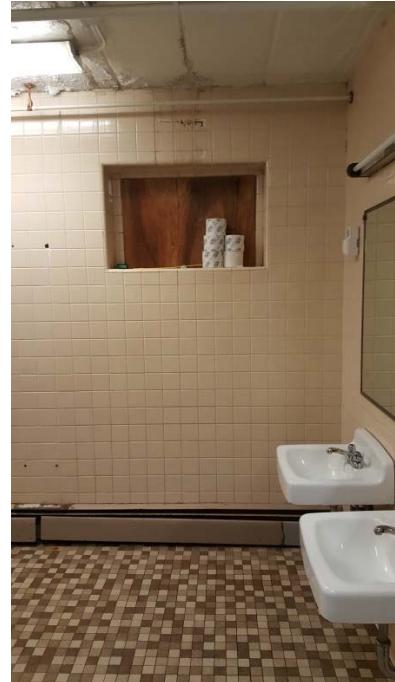
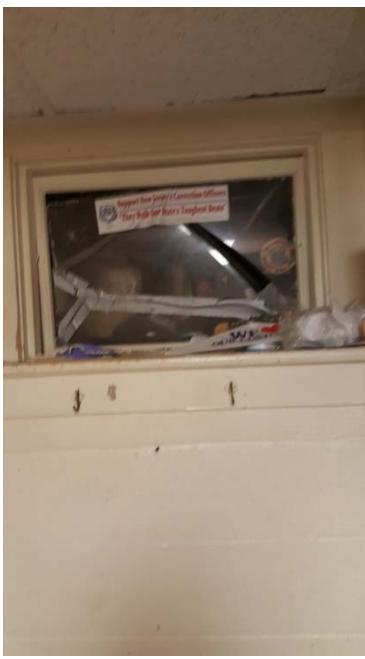
The photo to the right shows a boarded up window to trap heat in the bathroom during the winter months. Additionally, the top left of the photograph illustrates the water damage to the ceiling.

View of a broken window in the locker room.

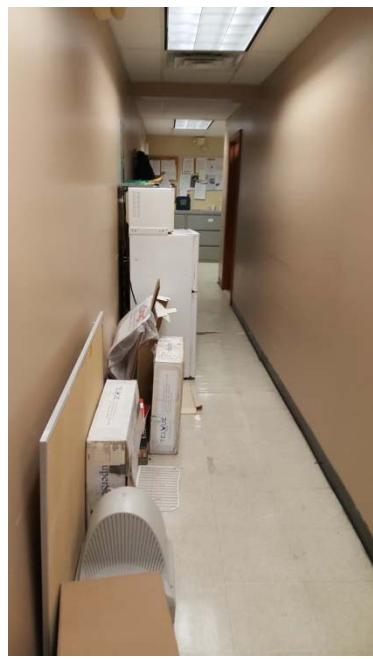
View of the aisles in the police department being used for file storage.

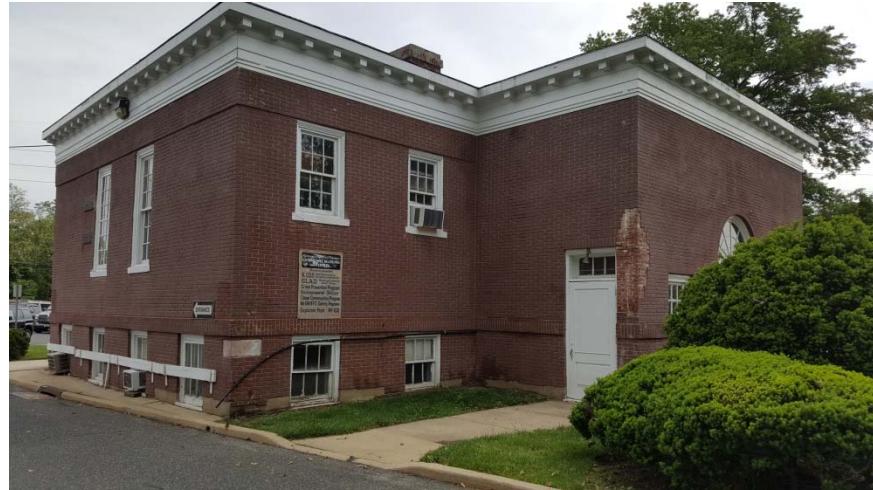
Accessory Building: Old Town Hall / Boxing Ring

View of the western façade of the building abutting the parking lot. The original building is brick masonry with brick cladding, which is showing signs of deterioration as illustrated in the above photograph.

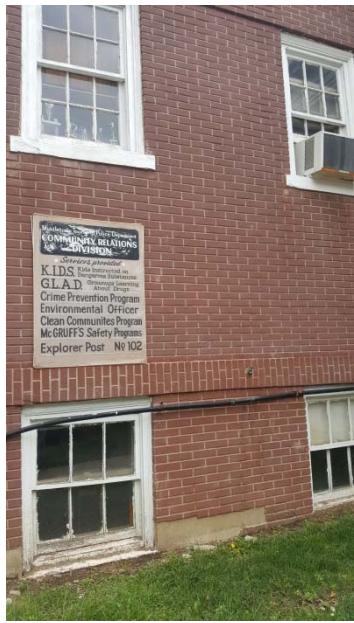
View of the western façade. The windows, although, not broken aren't energy efficient in terms of insulation. Exposed wires along the exterior of the building.

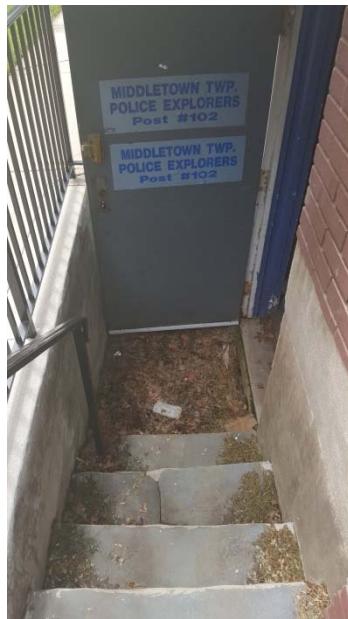
Stairs leading to the basement showing disrepair.

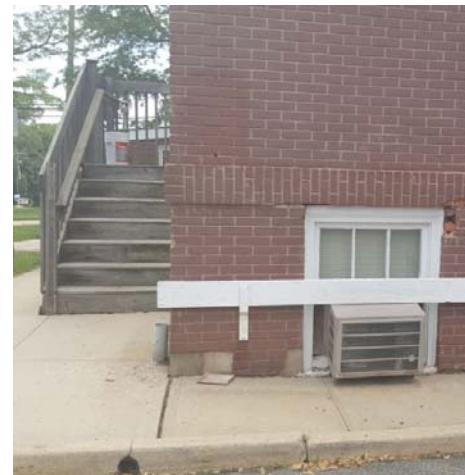
Western façade showing cracked brick cladding and exposing the original brick masonry. Inefficient heating and cooling. Air conditioning provided by window units.

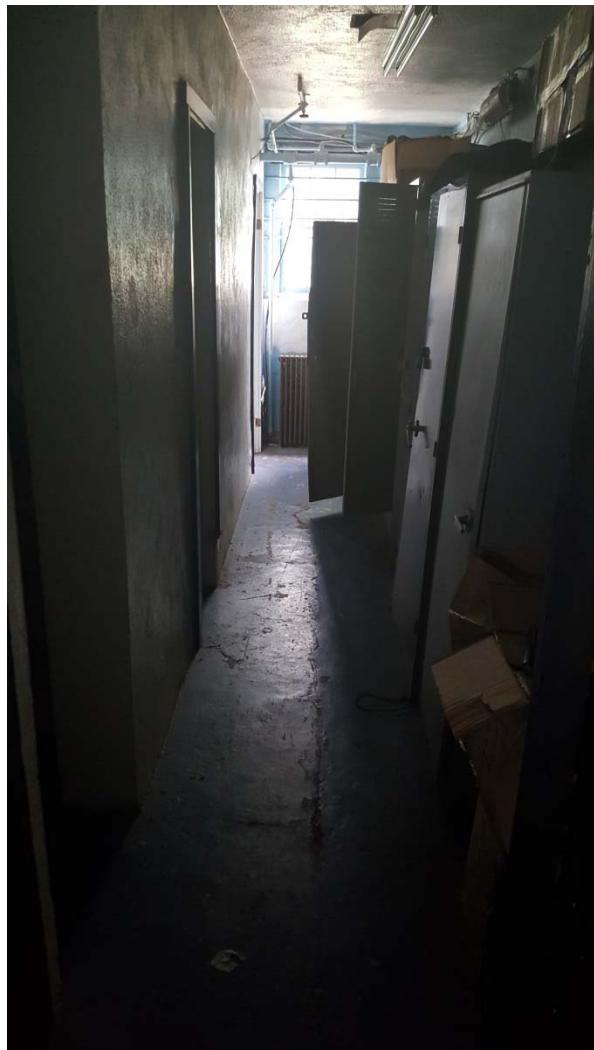
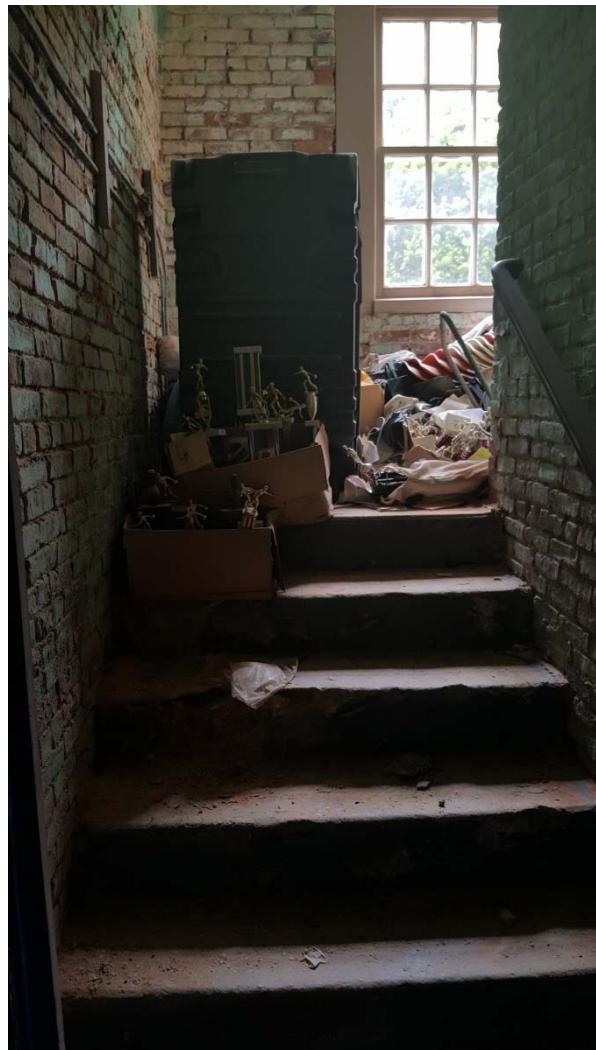
View of the interior of the building at the basement level. The basement is used for storage.

The aisle way is used for storage. Please note the cracked floors and exposed plumbing and wires.

Dilapidated staircase leading to the upper level. Although the window are not broken, there is no insulation.

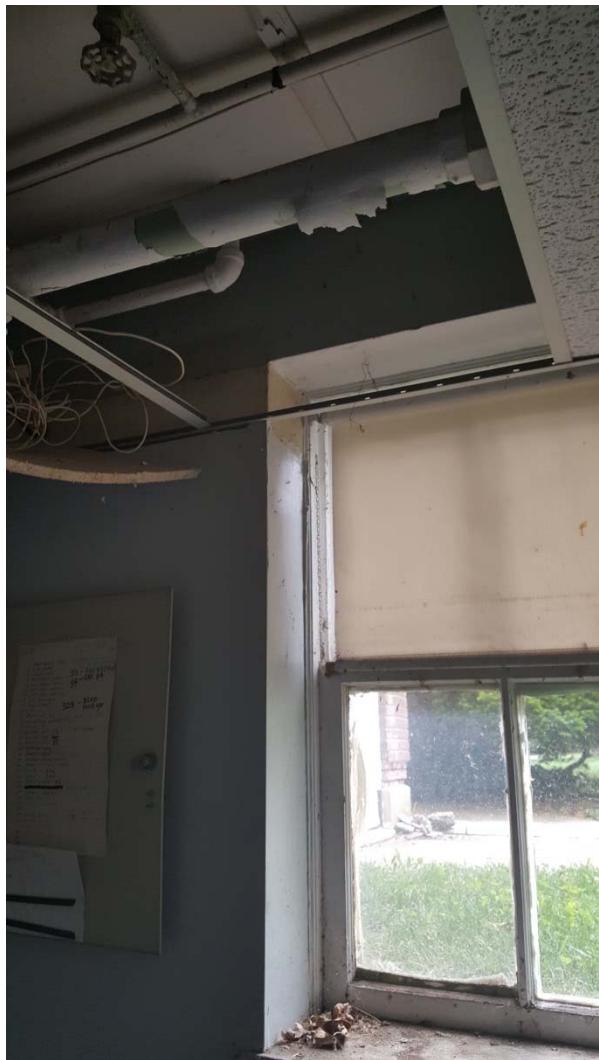
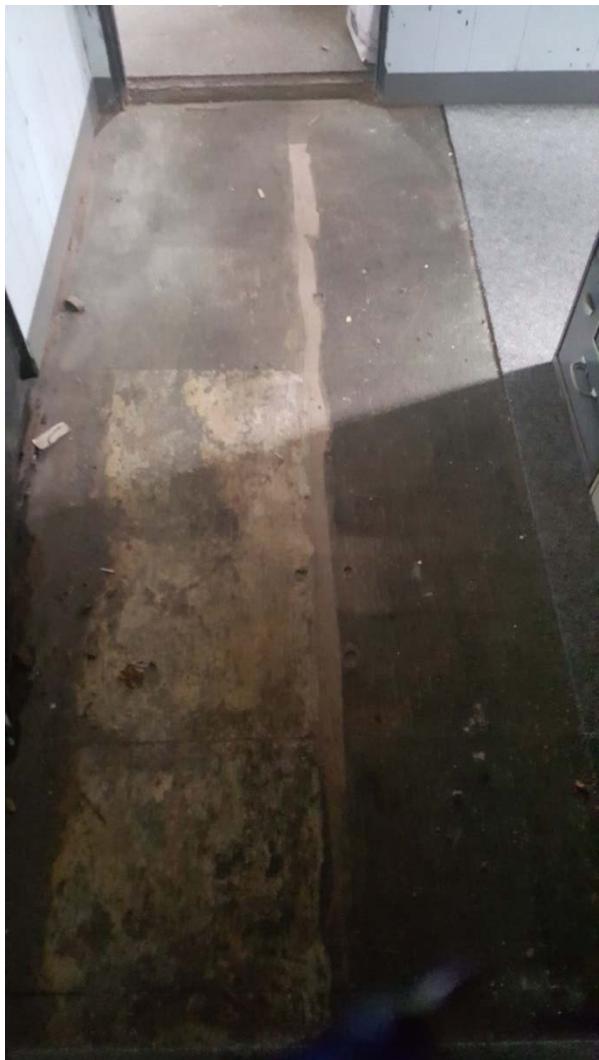
View of the interior of the building at the basement level (continued)

Interior of the storage space. Note the cracked/broken ceiling tiles and exposed plumbing and wires.

Floor is in a state of disrepair.

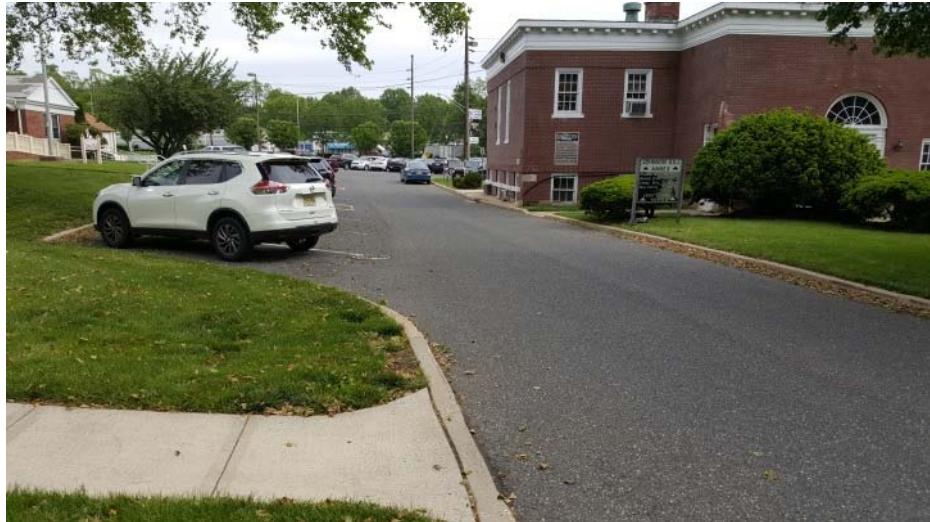
One way entrance driveway from Kings Highway into the administration building.

Regarding the overall parking, there is inadequate parking for the expanding municipal offices and their various functions. The parking design is not in accordance with the current engineering standards and the vehicular circulation creates unsafe conditions. The parking lot provided for overflow parking is isolated from the main complex. The lot provides handicapped parking but there is no connectivity to the main areas and therefore a wheelchair bound person would have to traverse across the lot on to Kings Highway to access Johnson Gill Annex thereby creating unsafe conditions. Although this parking lot is connected to the Planning and Community Development building, which in turn provides a walkway to Johnson Gill Annex (located at lower topographic elevation); there is no easy access between these spaces, the Planning Department and Johnson Gill Annex. This parking lot leads to the gravel driveway, used by the Planning Department and the ambulances; there is no clear demarcation between pedestrian and vehicular traffic at this point. The impound lot abuts the residential properties. Typically to be in compliance with the Township’s ordinance, a 50-foot buffer would be required. The existing conditions do not comply with this requirement. Overall Lot 1.01 exhibits conditions of environmental contamination, obsolescence, obsolete layout, outdated facilities and faulty arrangement or design and thus may satisfy the “D” criterion. Redevelopment of this area is necessary to correct the concerns of safety, welfare and the detriment posed to the safety and health of the community.

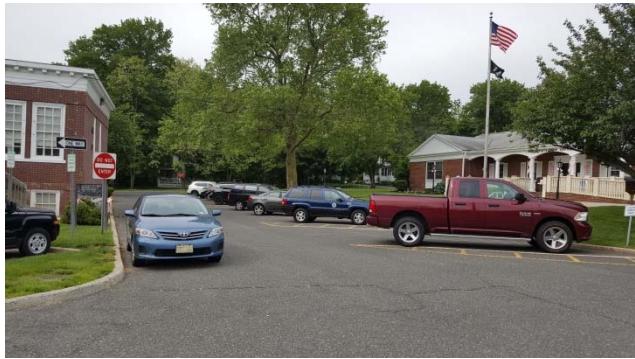
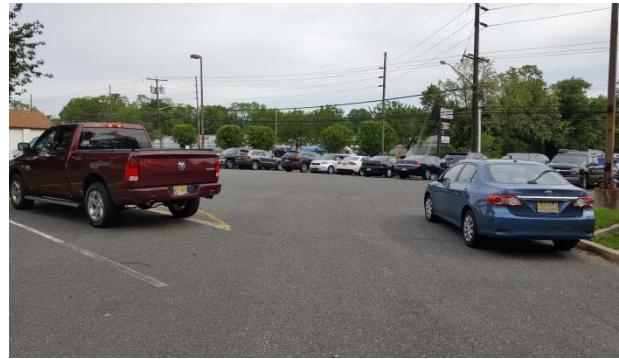
Left: View looking towards Kings Highway. Right: View looking towards the parking lot located to the northeast of the administration building.

Note the parallel parking in unassigned spaces due to lack of adequate parking.

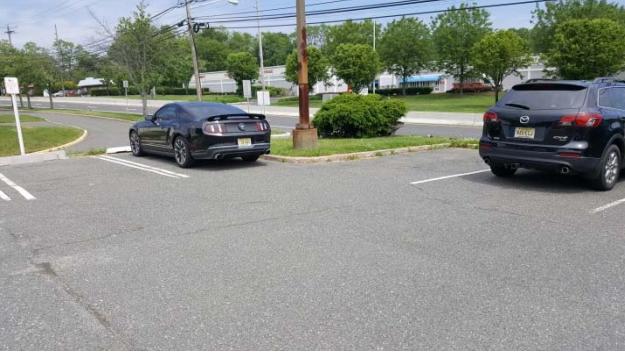
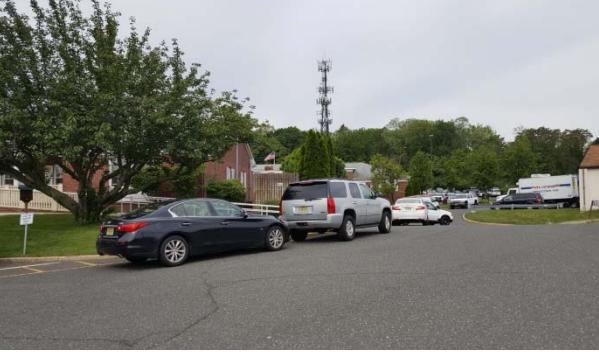
<p>View of the parking spaces to the northeast of the administration building and egress to State Highway 35. The above parking spaces are too close to each other creating unsafe conditions; the design is obsolete and not in accordance with the current engineering standards.</p>	<p>View of the one way driveway leading to the police garage building. Note parallel parking in unassigned spaces due to lack of adequate parking. This driveway leads to the parking area located to the west of the administration building, police garage, and Johnson Gill Annex.</p>

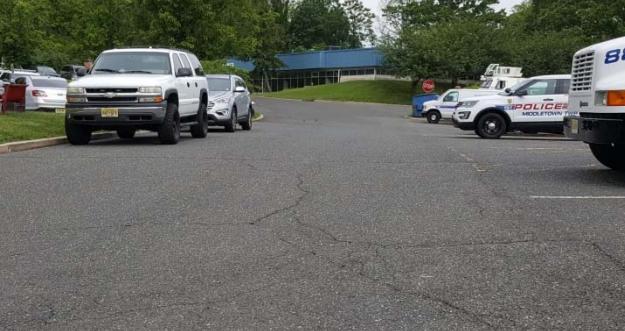
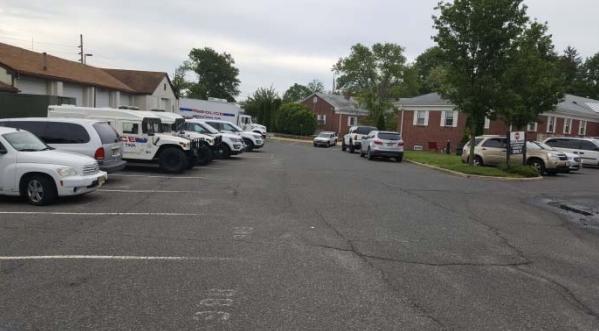
<p>View looking towards Johnson Gill Annex from the parking area to the north of the administration building. Note the parked cars in unassigned spaces due to inadequate parking.</p>	<p>View of the parking lot looking towards the administration building from Johnson Gill Annex. Please note the unassigned parallel parking.</p>

<p>The above images illustrate the lack of adequate parking and as a consequence leading to unassigned parallel parking along driveways.</p>

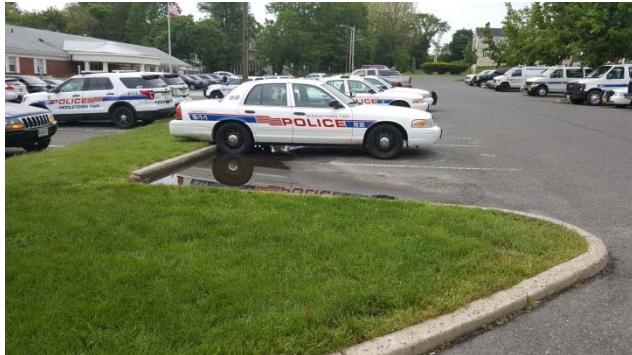
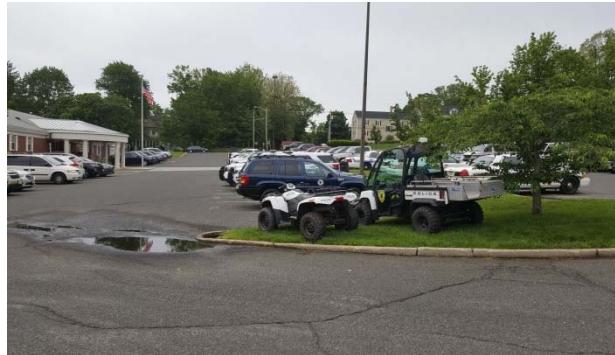
View of the parking lot to the west of the median separating the lot from the parking lot immediately to the west of the administration building.

View towards Kings Highway and second access drive to the west of the administration. Please note the vehicles parked on the grass due to inadequate parking, potholes, lack of defined parking, etc.

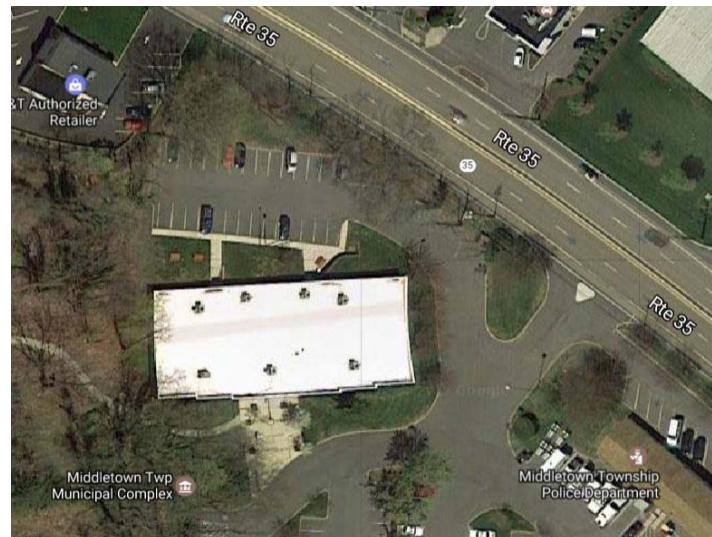
View of the entrance drive from State Highway 35 to the northeast of Johnson Gill Annex. Note the access driveway to the police garage immediately off the entrance. This is a one way ingress drive. The design creates potential conflicts.

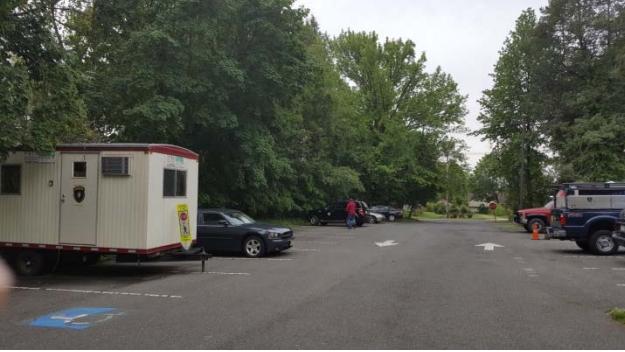
<p>View from the overflow parking, looking towards Kings Highway. Although this is a part of Block 815, Lot 1.01, it is separated from the rest of the lot by a wooded area, and the only access is from Kings Highway.</p>	<p>View to the east of the overflow lot showing handicapped parking. The parking lot requires maintenance. Most importantly, these handicapped spaces are isolated and there is no direct access to the buildings from these spaces.</p>

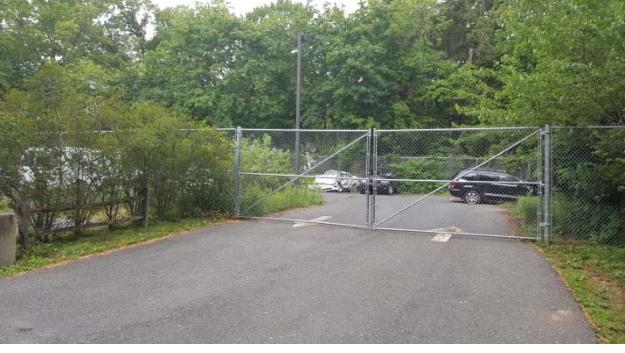
<p>View of the police impound lot, which is an area demarcated within the overflow parking with a chainlink fence.</p>	<p>View towards the overflow parking lot from Block 815, Lot 6 (the Planning and Community Development Department). Note the gravel driveway.</p>

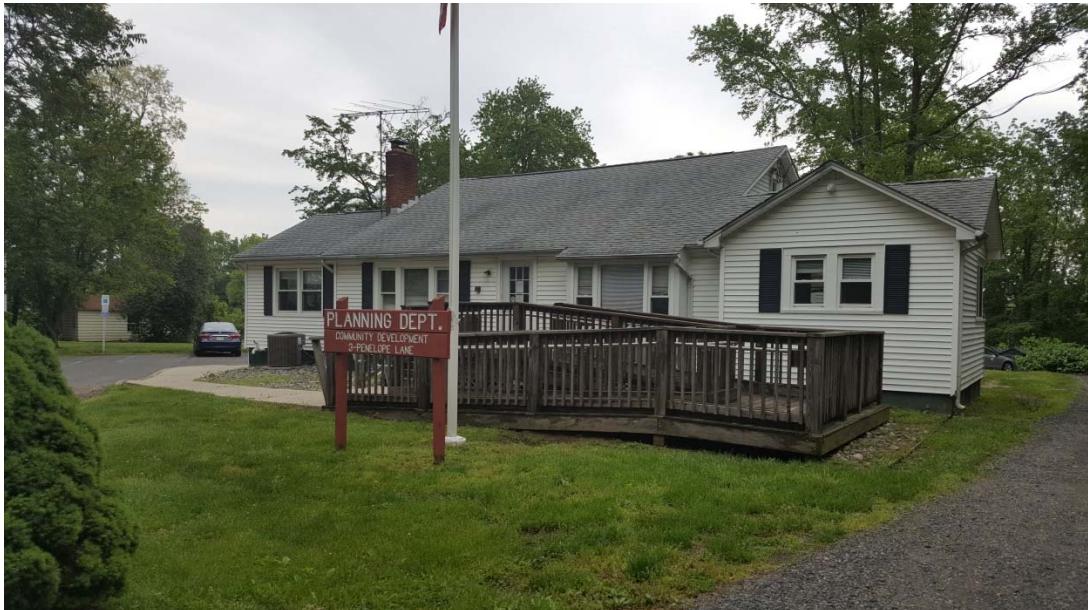
View of the Planning and Community Department from Penelope Lane

As demonstrated in the above images, this building is an existing house that was converted into an office use. Although the building is habitable and ADA compliant in terms of an access ramp provided at the entrance, the building design is obsolete and does not provide adequate space to satisfy the department's need. There are ongoing maintenance issues in terms of inefficient heating, ventilation and air-conditioning thereby requiring window units to be fitted during summer months and portable heaters during winter months.

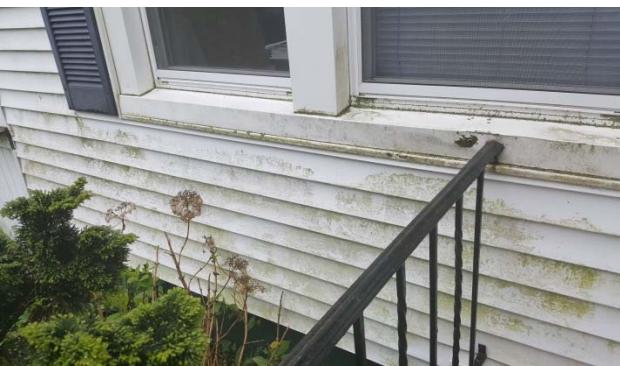
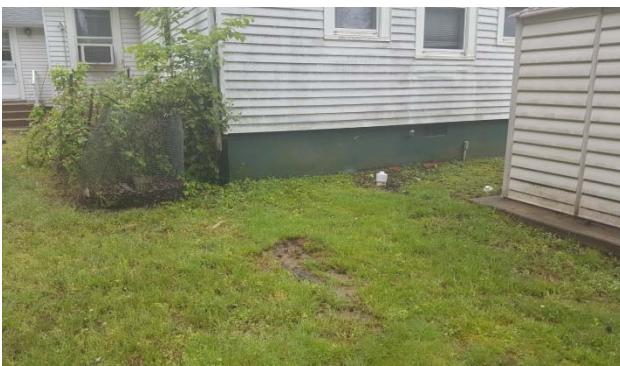
<p>View of a portion of the northern façade showing signs of decline.</p>	<p>View of a portion of the eastern façade showing signs of decline.</p>

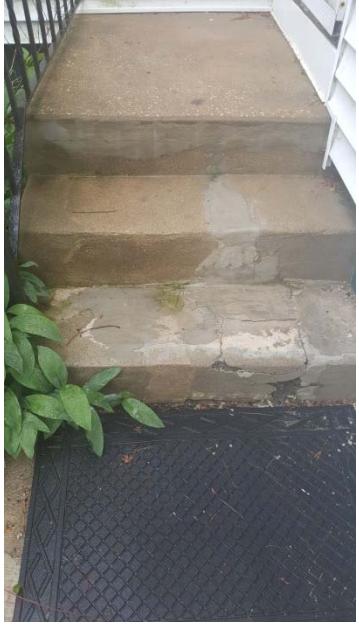
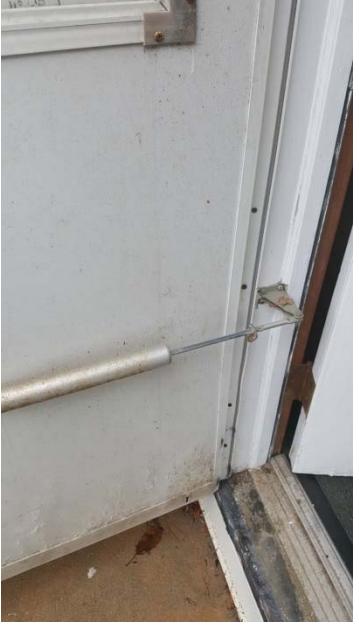
<p>View of the steps to the emergency exit located to the north of the building showing signs of disrepair.</p>	<p>Storm door at the emergency exit located to the north of the building showing water damage.</p>

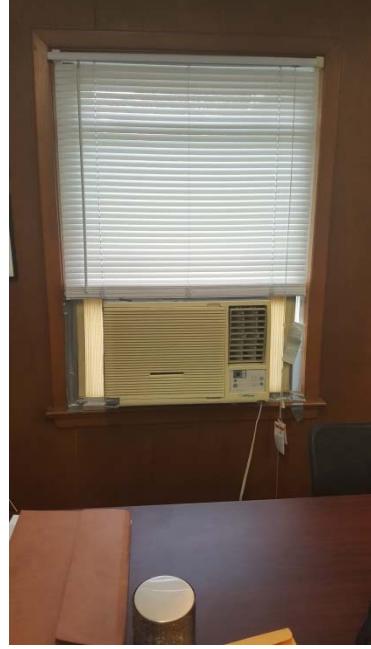
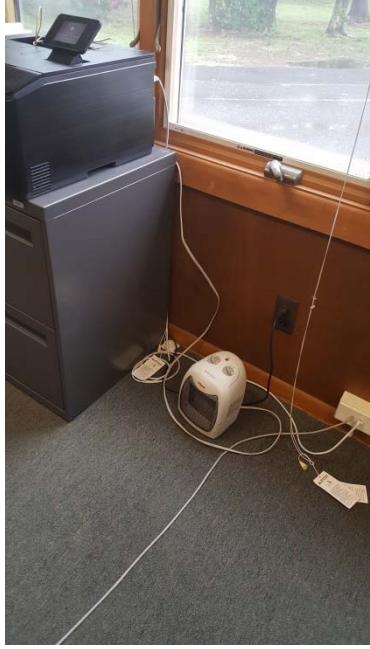
<p>Wood panelled office space, which was originally a sunroom. Lack of insulation, inefficient heating and airconditioning requiring window units to be fitted during summer months and portable heaters during winter months.</p>

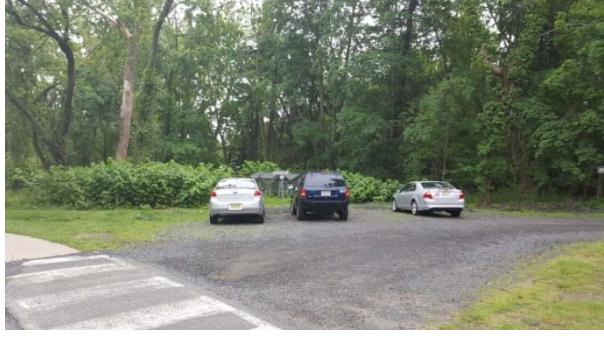
<p>View of the gravel parking area located to the east of the building.</p>	<p>View of the one way gravel driveway providing egress from the property.</p>

The driveway to the parking lot serves both the Planning and Community Development Department and the EMS. There is one handicapped space provided approximately 60 feet from the entrance driveway. The curb cut, to access the building, is located at a distance of approximately 40 feet from the entrance driveway. This driveway is utilized by both visitors to the Planning and Community Development Department as well as ambulances parked in the EMS building on lot 7. This creates a potentially unsafe condition and a pedestrian and vehicular conflict. Additionally, this building is isolated from the rest of the Township's related departments such as zoning and building construction, which are located in Johnson Gill Annex. There is no direct vehicular access between the Planning Department and Johnson Gill Annex and causes inconvenience to the residents who have to go back and forth from the various departments. Overall, the site design is obsolete and satisfies the "D" criterion.

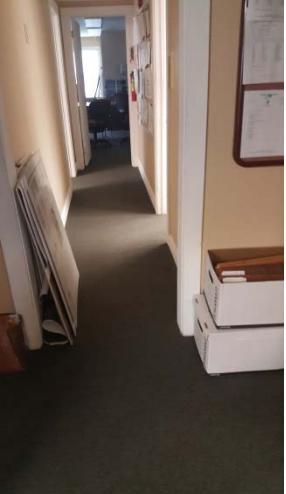
<p>ADA noncompliant aisle space that is exacerbated with storage of files. Inadequate space available for file storage.</p>

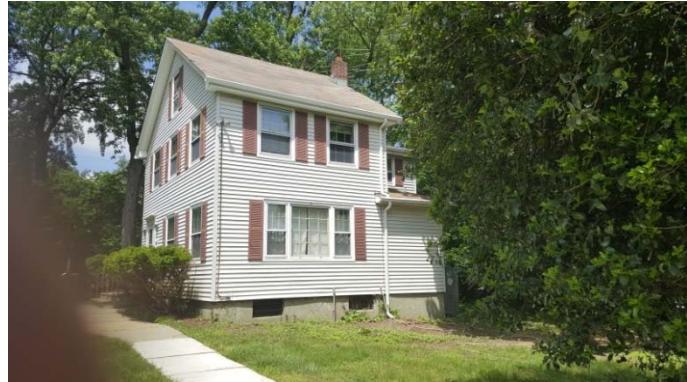
Above: View of the building looking towards west.
 Below: Basement and foundation showing signs of deterioration.

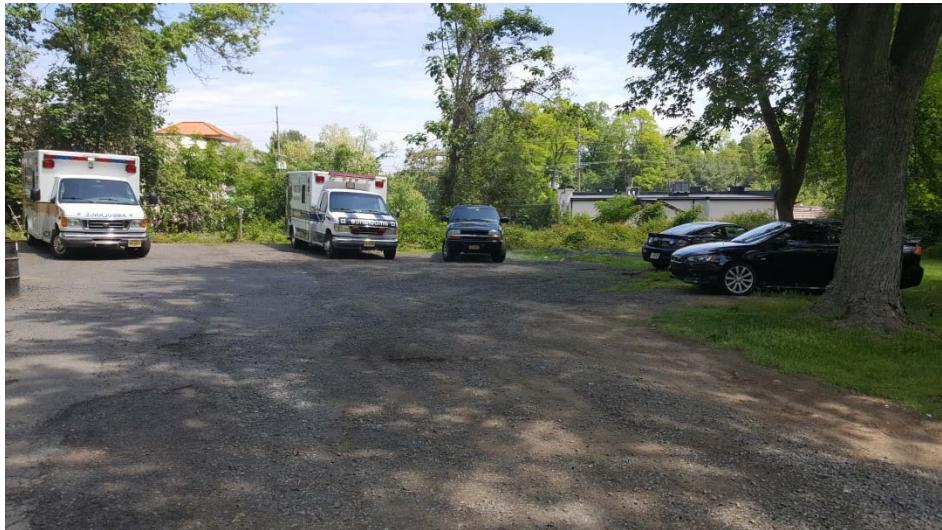
Above: View of the gravel parking lot from the shared driveway with the Department of Planning and Community Development.

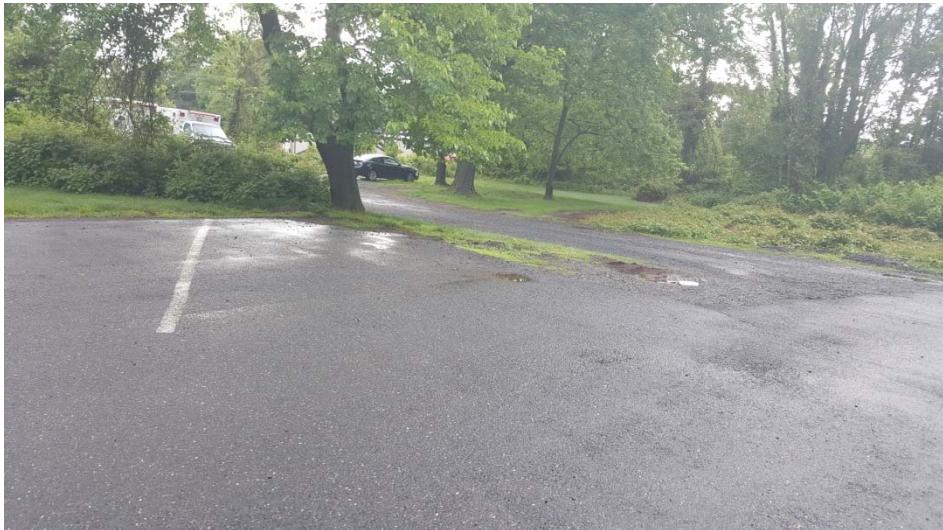
Below: View of the narrow access driveway to the parking lot serving the EMS.
